# **THE REFURBISHMENT OF STOCKPILE ARMCO TUNNELS WITH CONSIDERATION TO CORROSION DEGRADATION AND STRUCTURAL INTEGRITY ISSUES**

**C. Hutchinson, Dr. P.A. Farinha  
and P. Brinsley\***

**Extrin Consultants  
Suite 1, 28 Burton Street  
Cannington WA 6107**

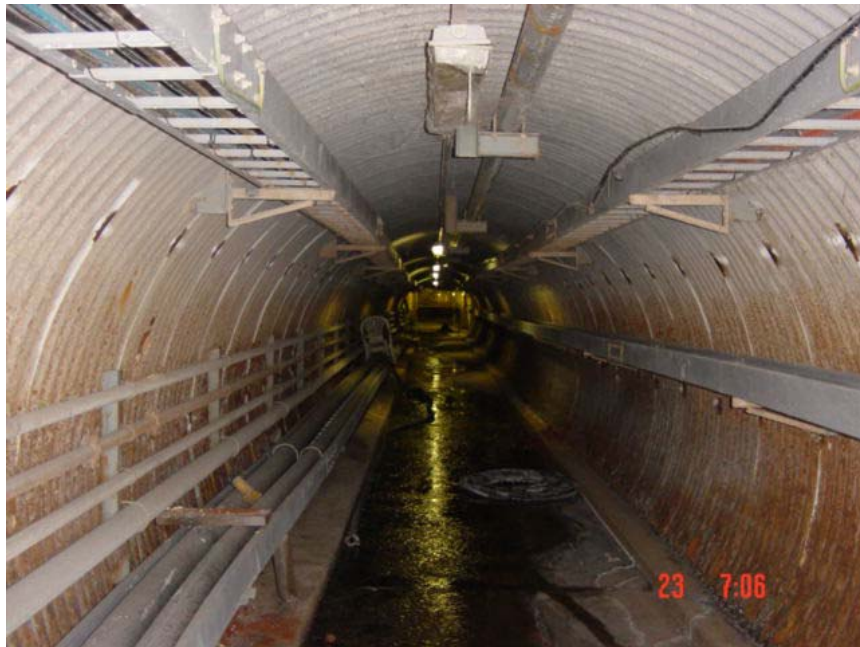
**Fig II: General view of Escape Tunnel prior to refurbishment. Note the corrosion degradation at the lower third of the tunnel.**

Visually, the tunnels internally presented a substantial degradation to the lower section particularly at the tunnel wall/concrete in fill floor interface. This location is where the majority of washdown is concentrated and the ponding and settlement of wet process material is evident. The problem was further exacerbated with the apparent movement of the wall away from the concrete floor which not only increased the extent of washdown water entering at the tunnel wall/floor interface but was also evidence of tunnel deformation. The water used for the washdown and the subsequent dust suppression of the ore is extremely saline and aggressive with chloride levels in excess of  $32,000\text{ppm}$  as analysed. The major concern observed during the surveys was the apparent deformation of the tunnels at locations which suggested a substantial weakening of the structure.

The second option provided and ultimately selected for the project was the re-lining of the existing tunnels using galvanized Multiplate sections of varying thicknesses and sizes. As this type of project had not been undertaken before on such a large scale and under stringent parameters, the pre-project engineering and structural knowledge necessary to investigate, understand the previous, current and future requirements of the structures was considerable.

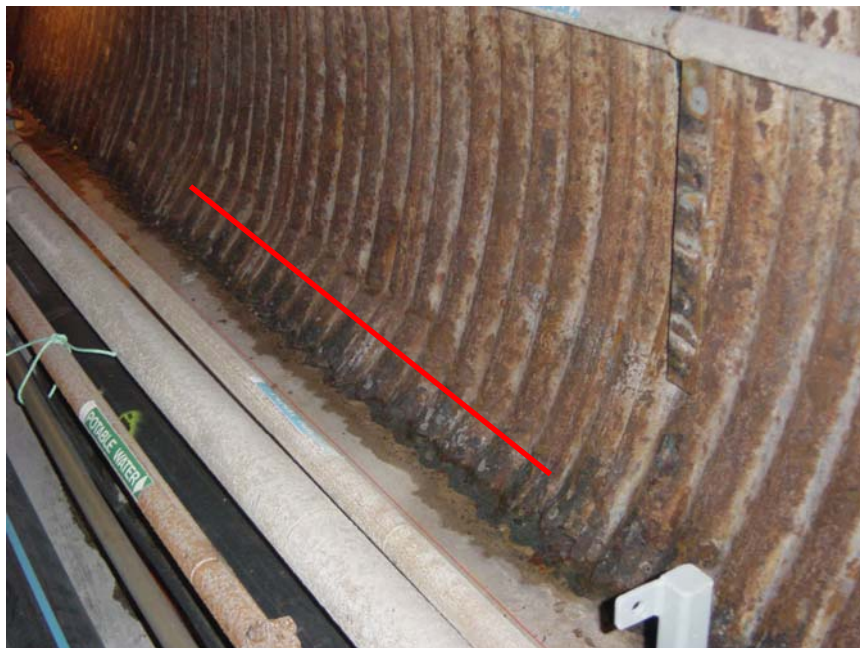
The first step in providing the client with options to rectify the corrosion concerns was to clearly “define the problem”. Visually, it was possible to determine the extent of corrosion to the tunnels internally, yet externally, the condition of the tunnel steel was an uncertain parameter. Using ultrasonics, thickness measurements were obtained, yet the merit of the readings was questioned due to the extent of degradation and curvature of the corrugation perhaps giving ambiguous findings. For the purpose of accuracy, sections of the tunnel were removed to view the back surface of the tunnel walls. Removing 100mm diameter steel sample coupons at select locations throughout the tunnels provided several pieces of useful information. Firstly it allowed for visual assessment of the backface of the tunnels to ascertain the corrosion morphology but most importantly it allowed for accurate measurement of the remaining steel thickness. Coupon retrieval confirmed that the locations of most pronounced corrosion internally (lower third of the tunnel) were also replicated externally where backfill saturation was evident. In most instances the zinc galvanizing layer had been consumed by corrosion and the steel was actively corroding.

Additional to the coupon retrieval, potential measurements (versus Copper/Copper Sulphate reference) were taken along the length of both structures with potentials in the vicinity of  $-500$  to  $-600\text{mV}$  indicative of that of corroding carbon steel. These potentials also verified the widespread loss of the galvanised coating.

**Fig III: Close up view of corrosion degradation typical in the Escape Tunnels. Note also kink in the tunnel wall above red indicator line.**

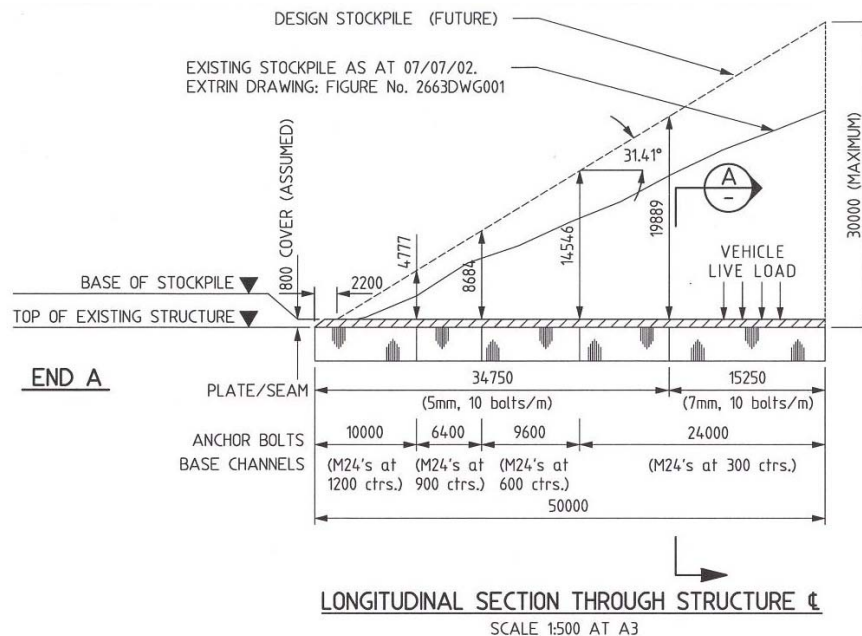
**Fig IV: Tunnel design parameters showing original and future designed stockpile.**

From the review of all information obtained during site surveys, and based on the results of structural calculations, it was clearly evident that the existing stockpile tunnels were not sufficient to provide the service life expectancy as required. Additionally, it was evident that the current tunnel integrity was in question and the extent of existing corrosion degradation had resulted in the tunnels deteriorating to such an extent that safety measures had to be implemented to prevent further tunnel deformation or collapse. The need to refurbish the tunnels had now become paramount as continued deformation of the tunnels may have led to the inability to refurbish the tunnels and thus result in the tunnels being condemned. The direct result of this would have meant the removal of the entire stockpile to either remove and reinstate these tunnels or resituate the stockpile. Both options held severe cost ramifications.

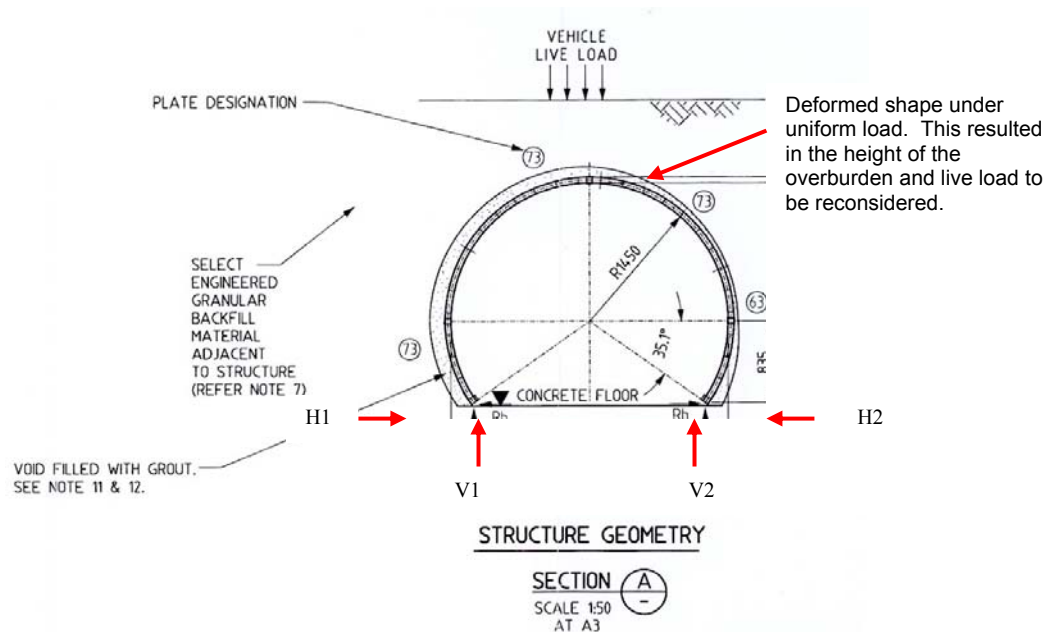
The new designed internal arch section took into consideration all existing and future load requirements. At the base of the new arch section the horizontal and vertical forces (see Fig V) had to be accommodated by the existing concrete base which would have a substantial compressive force.

**Fig V: Section showing new tunnel liner within existing tunnel at “worse case” location of tunnel deformation. Note the offset.**

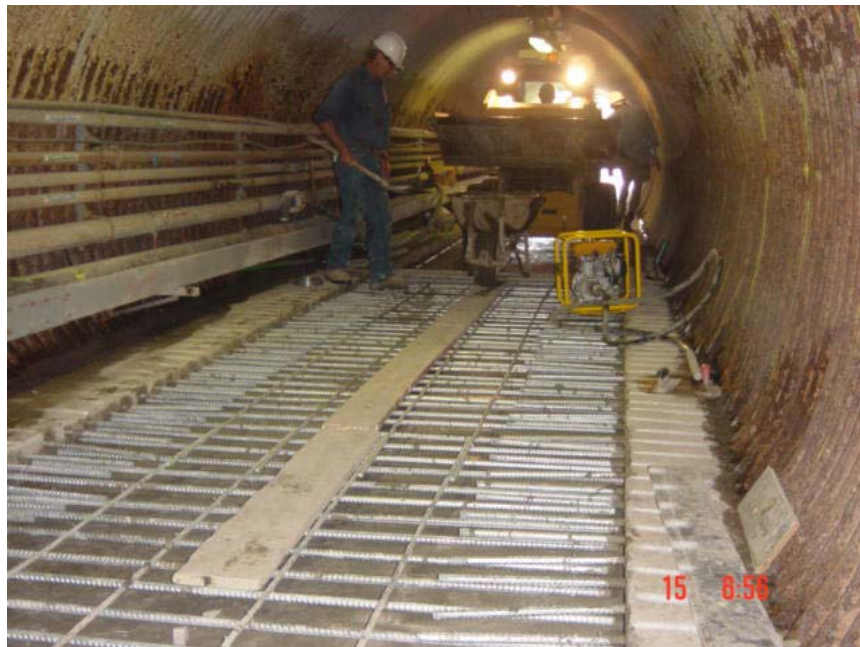
Fig VI: Photograph showing existing concrete floor strengthening prior to undertaking tunnel placement.

To facilitate the placement of the new internal tunnel liner, the first undertaking was to reinforce the existing sound concrete floor to ensure its ability to handle the increase in stockpile height. Reinforcement of the existing floor was critical as removal of the floor may have resulted in the collapse of the existing (original tunnel liner). Structural calculations concluded that with considerable reinforcement placement and infill placement, the floor would handle the loads to be imparted. Design specifications specified that another 780 metres of galvanized Y20mm reinforcement bars be drilled and grouted into the existing concrete floor. Additionally, prior to any concrete placement the floor was high pressure water washed with potable quality water followed by abrasive blasting prior to the application of a bonding mortar.

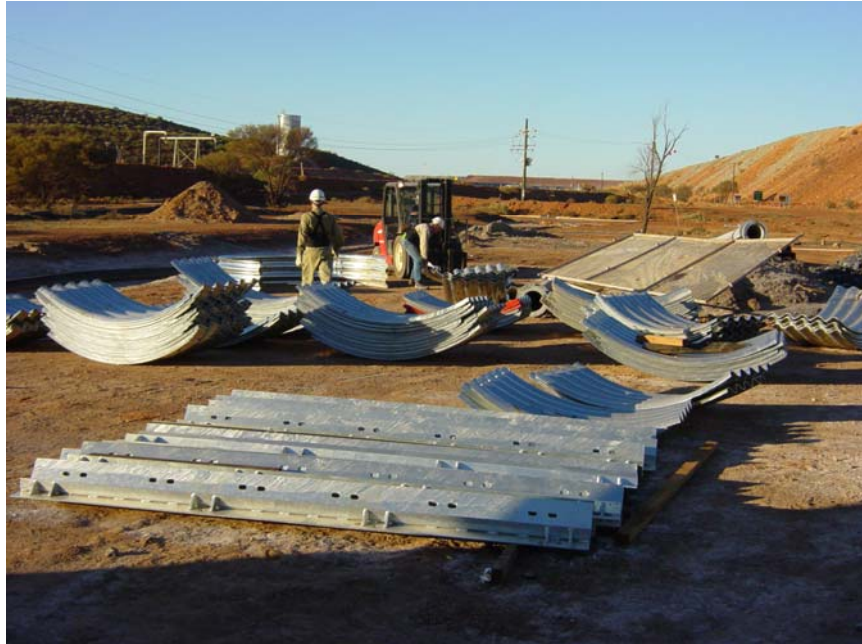
**Fig VII: Photograph showing new tunnel sections and fabricated angle bases as unloaded on-site.**

As the client required a minimal loss of tunnel internal dimensions and as the existing services prevented too much movement within the tunnels, a void of approximately 200 -250mm was all that was left to work with between the tunnels for bolt fixing. As a result, a four plate closure system was incorporated which was then fixed to a modified angle section bolted to the modified concrete floor. To facilitate the forecasted increase in stockpile height, design requirements resulted in the first 15 metres of tunnel fabricated from 7mm plate with the remaining 35 metres requiring 5mm plate.

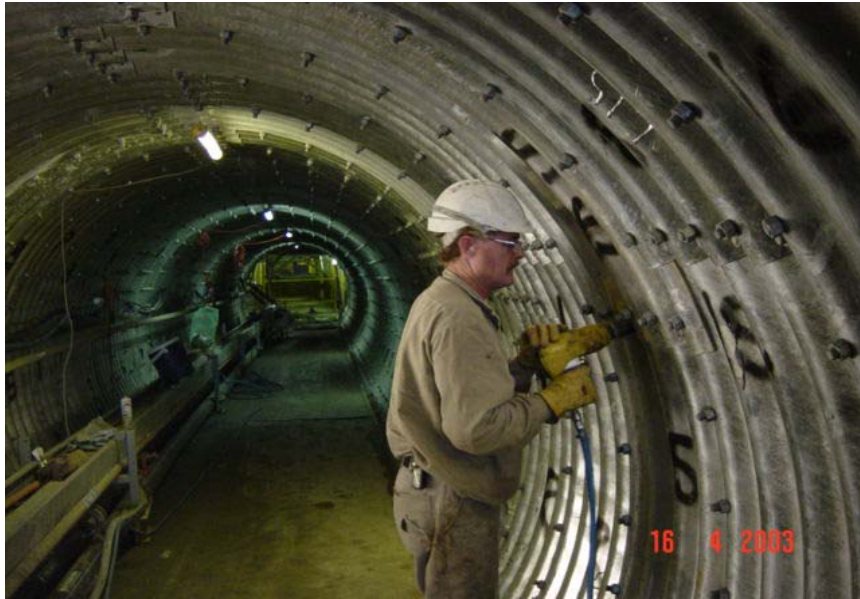
**Fig VIII: Photograph showing new tunnel sections being torqued after installation.**

Lifting of the individual plate sections (100+kg) into the required position was in itself a challenge, as tunnel height and movement restrictions due to existing services prevented the use of such machinery as forklifts or bobcats. To overcome this concern, a modified electric walking pallet stacker unit was utilized and provided the lift and movement required of the heavy plate sections.

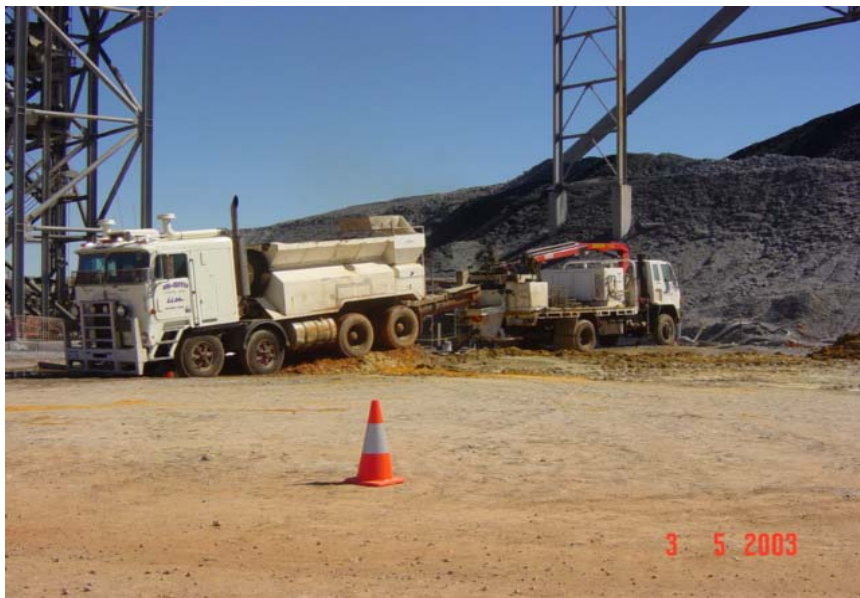
**Fig IX: View of grouting truck arrangement. Concrete was batched on-site due to remoteness and pumped directly into spray unit hopper.**

To prevent movement between the two tunnels and to provide extra added protection of the newly placed steel liner, the void between the two tunnels was filled with a flowable grout. Placing the grout required that sockets be pre-fabricated into the new liner plates at select locations and intervals, so the grout could be added as desired to ensure that no bridges or voids were evident between the two tunnels. Design calculations required a grout strength of 5Mpa, yet at the time of placement, a mix of 15Mpa minimum was used.

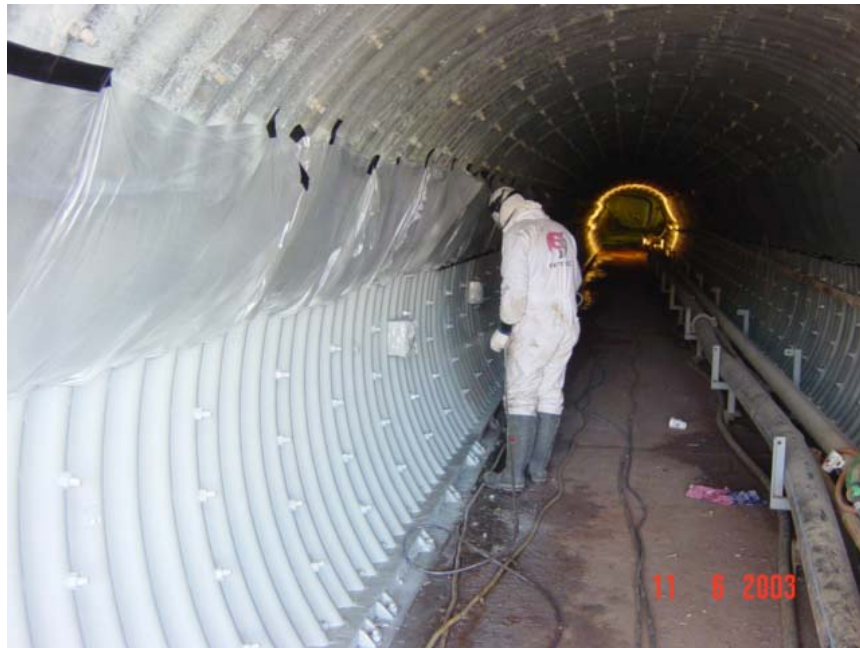
Fig X: Photograph showing spray application of “splash zone” coating to tunnel wall.

To facilitate extending the period of “time to first maintenance” it was determined that a “splash zone” coating to the lower sections of the newly placed galvanised sections where hypersaline wash down waters are most heavily concentrated, should be applied.

The walls were high pressure water/detergent washed prior to the surfaces to be coated receiving a whip blast to provide some profile on the galvanized wall prior to coating application. An epoxy mastic system was selected as the coating most suited to provide the protection required. All bolts, nuts and join locations were first “stripe coated” by brush to ensure the location was well coated.

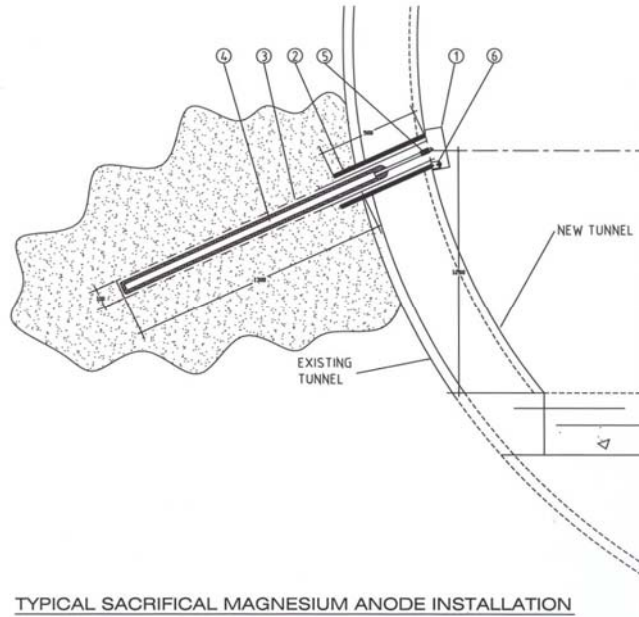
Fig XI: Figure showing sacrificial anode placement into tunnel walls.

Externally, the main concern with the tunnels is the exposure to the hypersaline dust suppression water, which resulted in fitting a sacrificial anode cathodic protection system. Previous cathodic protection trial investigations showed that the tunnels were not electrically isolated from such assets as services or overhead conveyor stacker legs. As a result total protection from cathodic protection could not be assured. A partial protection cathodic protection system was designed and implemented to reduce the incidence and severity of corrosion, further extending tunnel service life. Both the existing and new tunnels were electrically bonded to ensure that the cathodic protection would initially be used to slow the corrosion process of the existing tunnel, which in turn increases the time before exposure to the hypersaline water and backfill material of the inserted tunnel.

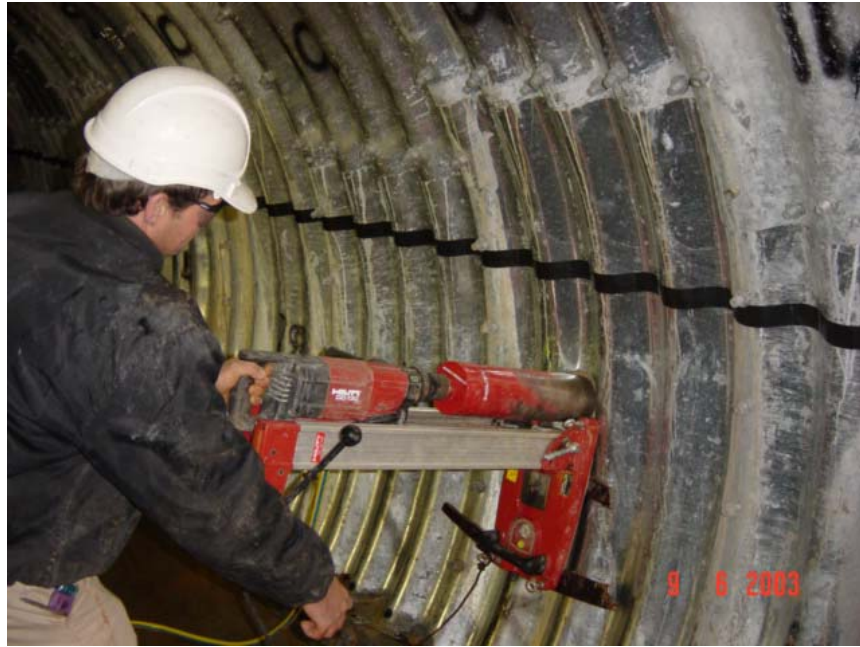
**Fig XII: Photograph showing coring activity through tunnel walls with diamond tipped core to facilitate anode placement.**

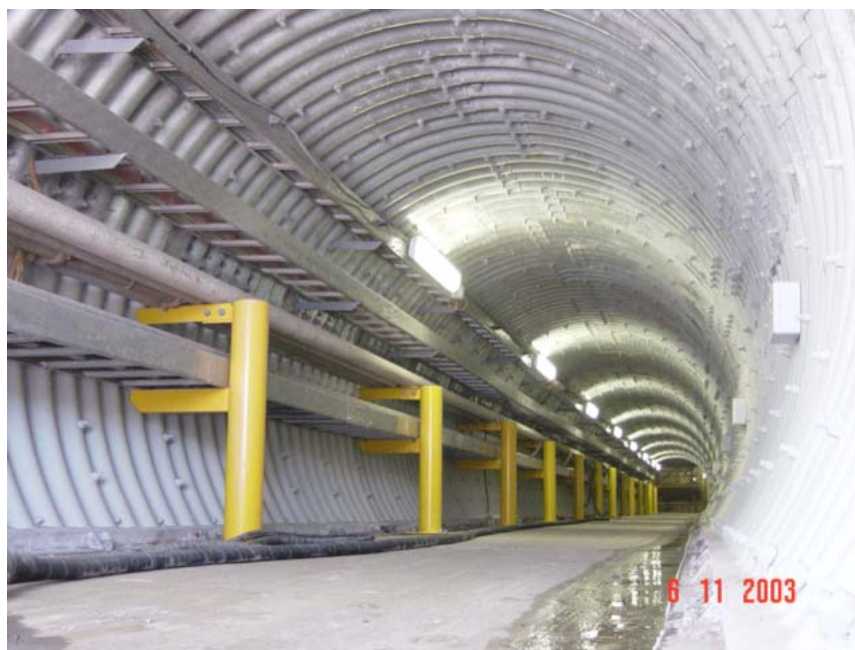
**Fig XIII: General view of refurbished tunnel with all service relocated.**
