# **The Effectiveness of Petrolatum Tapes and Wraps on Corrosion Rates in a Marine Service Environment**

**C. Hutchinson, P.A. Farinha  
and D. Vallini\***

**Extrin Consultants  
Suite 1, 28 Burton Street  
Cannington WA 6107**

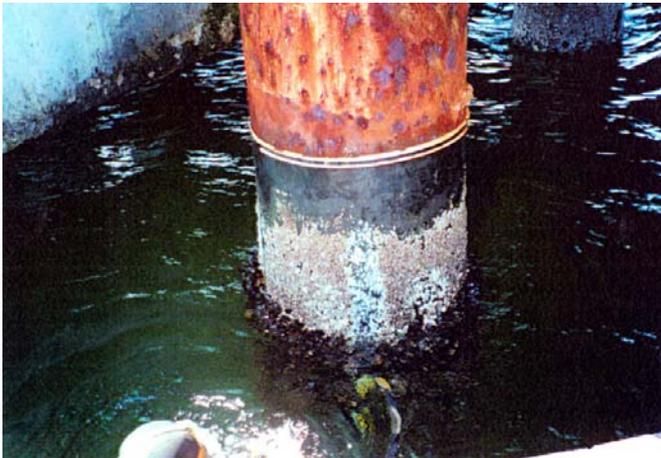
**Fig I. View of standard electro-fused sleeve system**

The original steel support pile wrap and sleeving system consisted of the application of a standard petrolatum tape followed by the encapsulation of the steel support pile with a electro-fused HDPE sleeve. The sleeve was then fixed using a mix of materials for strapping, including stainless steel and polyethylene. It was clearly evident from the results of the weight loss coupon trials undertaken over a two year period that the system was not adequately reducing the incidence of corrosion to the steel support piles (See Section 4 for test results).

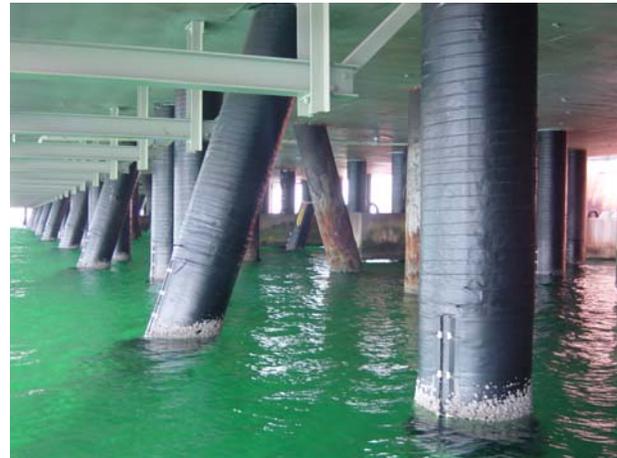
**Fig II. View of new tensioning rod sleeve system with additional atmospheric zone tape wrapping.**

Due to the findings of the initial testing, an investigation into a revised system based on the principles of the existing wrapping and sleeving methodology was implemented. The first change to the system was the installation of a petrolatum tape, the grease of which was dosed with a proprietary biocide in an attempt to reduce the colonization of (SRB) and thus reduce the incidence of MIC. The second and most important alteration to the system was the changes made to the external sleeving fixing arrangement. The original sleeve consisted of a 2mm thick HDPE sleeve which required electro fusing along the longitudinal seam to close the sleeve. Additionally, various bands of both non-metallic and metallic were incorporated periodically around the sleeve to hold the sleeve tight around the steel support piles. The newly specified sleeving system consisted of a thinner and more flexible poly vinyl/polyester that is fixed via a longitudinal tensioning rod system that provides for a more contour fitting than the original system. Correct tensioning prevents water flow between the jacket and the applied tape system.

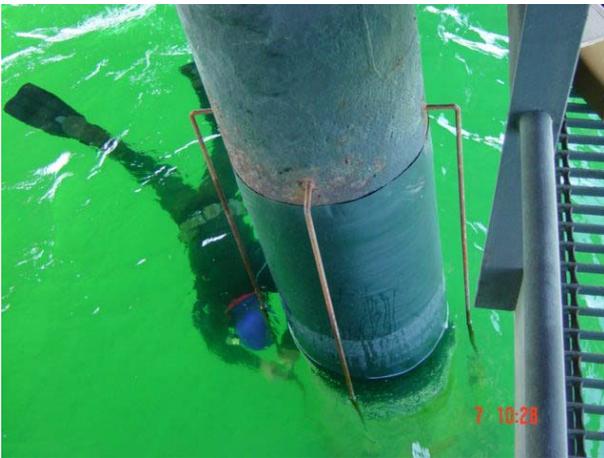
**Fig III. View of weight loss coupon control pile being fitted by a diver.**

The weight loss coupons at the two control pile locations were fitted outside of the installed pile wrapping and sleeving system to enable “real time” corrosion rates to be calculated to compare against those corrosion rates experienced below the tape and sleeve systems. The coupons were first fixed to a specifically designed round steel bar supporting bracket. This steel bar was welded above and below the pile sleeving system and bent at 90° to provide a parallel to the pile surface attachment point approximately 100mm offset from the wrapped pile face. The placement of the weight loss coupons was such that it placed them within the zone associated with Accelerated Low Water Corrosion (ALWC) and typically protected by the placed sleeving systems. **Refer to Fig III & V**

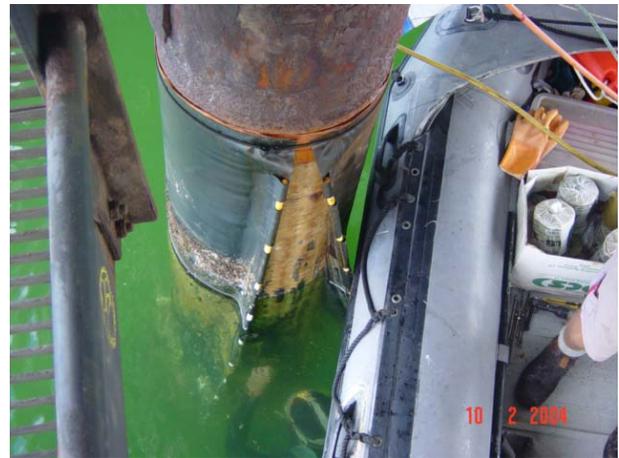
**Fig IV. View of tensioning rod sleeve weight loss coupon pile.**

The placement of the weight loss coupons on each of the monitoring piles was undertaken as follows: **Refer to Fig IV & V**

- All test piles were first high pressure water washed with garnet inclusion to class 2 over area to be protected.
- Weight loss coupon backing rods/plates (which provided a 5mm stand-off) were then welded to the steel support pile at RL 0.00 and situated 500mm above the bottom level of the sleeve to be placed.
- The entire prepared pile surface had an application of petrolatum primer.
- Coupons greased and placed onto backing rod/plate.
- Petrolatum tape applied in accordance with the manufacturers recommendations with minimum 55% overlap.
- Outer sleeve installed and welded/tensioned accordingly.

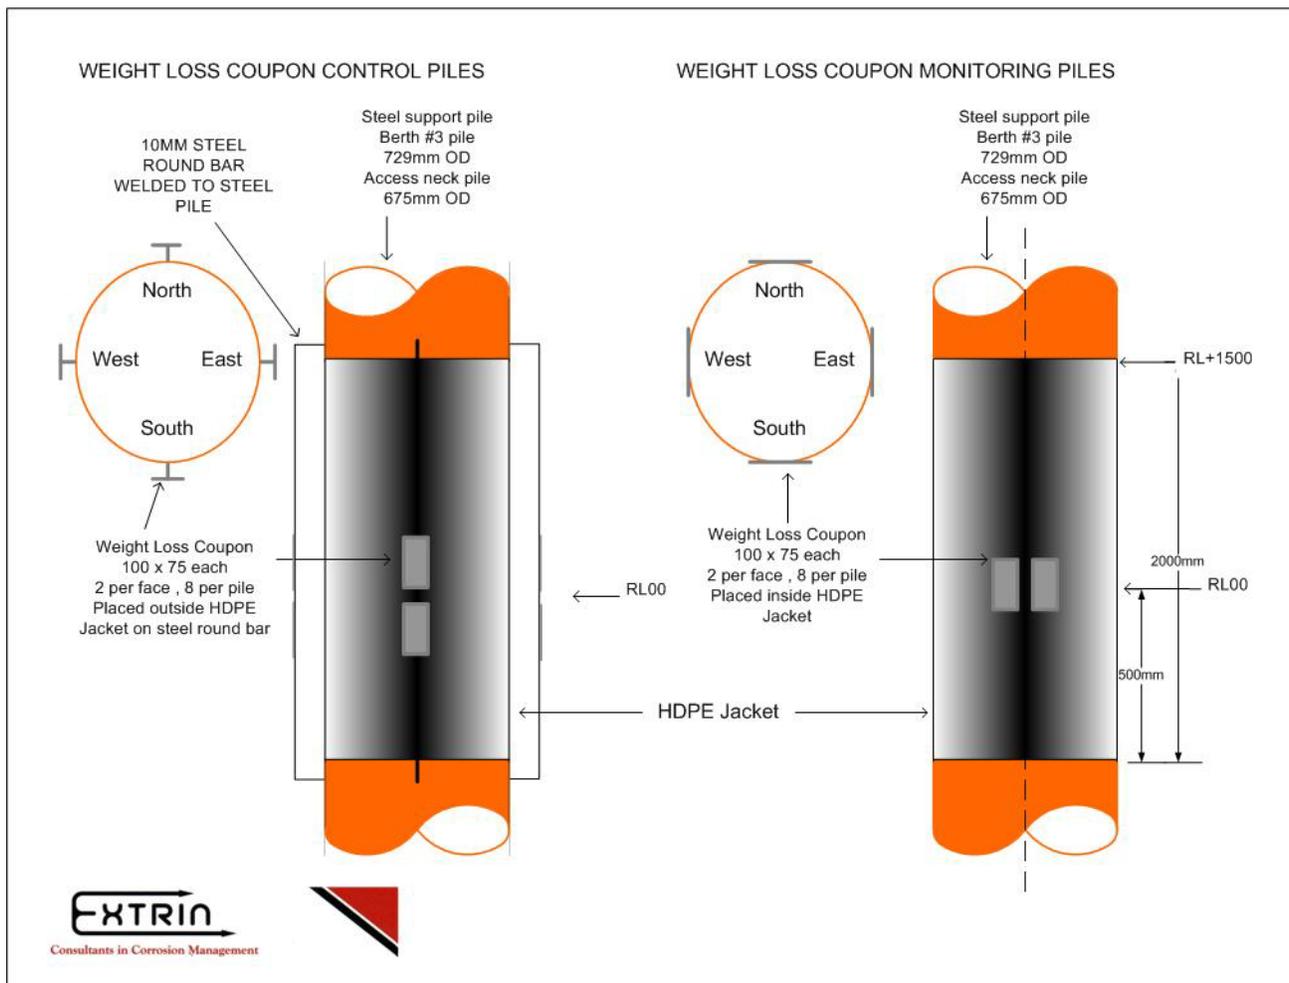
**Fig V: Drawing showing weight loss coupon arrangement on weight loss coupon control piles and monitoring piles.**

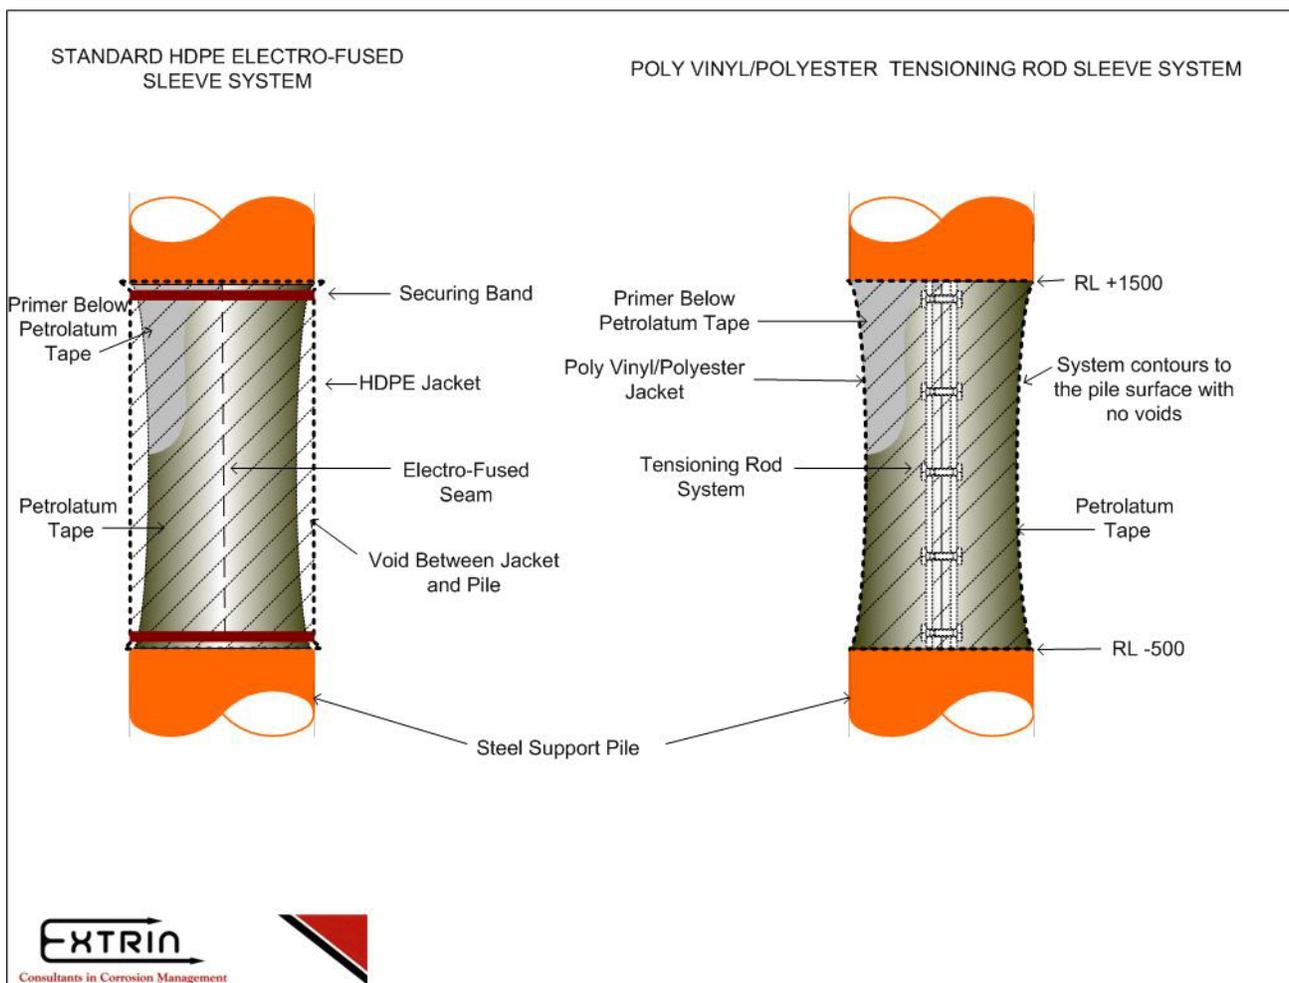
**Fig VII. Drawing showing standard HDPE sleeve system and tensioning rod sleeve system at locations of “hourglass effect”. Note how the tensioning rod sleeve system contours to piles surface thus reducing water/nutrient flow into and behind the sleeve system.**

The first noticeable finding with the two separate weight loss coupon trials was the importance of tightness or fit of the sleeves over the piles. The older original electro-fused sleeves although tight around the sleeve, did not contour the pile or adequately seal at the top and bottom which allowed for the ingress of water and nutrients with the tidal action. The new sleeve system incorporating the thinner sleeve material and tensioning rod system provided a far superior fit with the sleeve molding to the contours of the already corroded pile surface. This tightness of fit preventing any possible water flow between the sleeve and the tape/pile surface. **Refer to Fig VII**

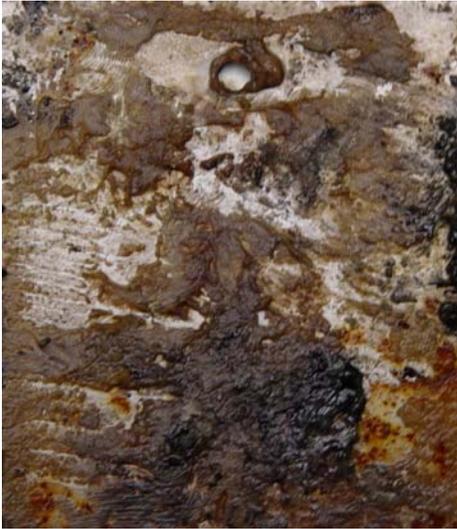
**Fig VIII.** View of weight loss coupon removed from below tensioning rod sleeve system prior to cleaning.

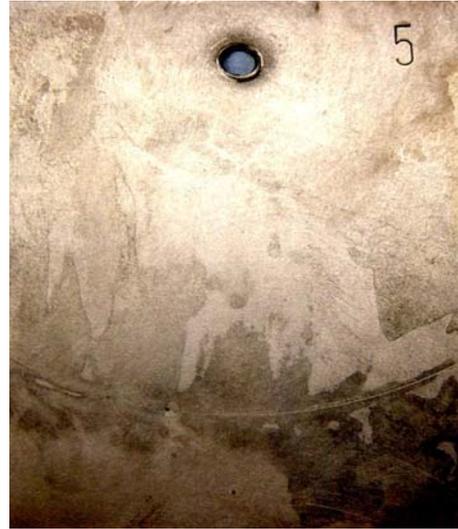
**Fig IX.** View of weight loss coupon removed from below tensioning rod sleeve system after cleaning.

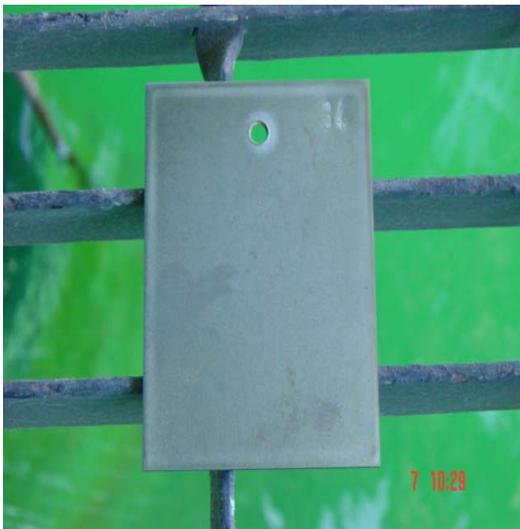
**Fig X.** View of weight loss control pile coupon prior to placement outside sleeve systems. (75 x 100mm)

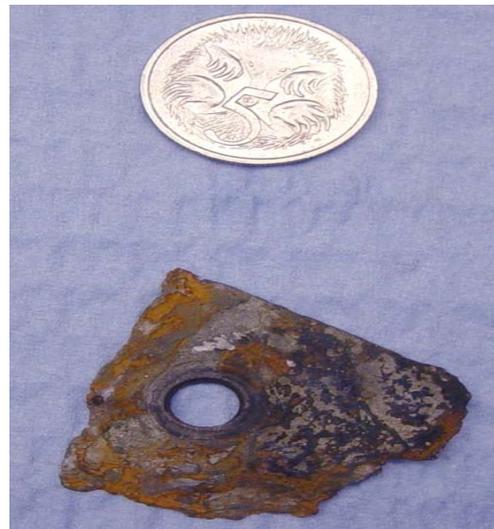
**Fig XI.** View of control pile weight loss coupon after 368 days exposure.

During the weight loss trials in 2004, control piles were also used to ascertain true corrosion rates for the marine environment to which the steel support piles were exposed. The results for the control pile coupons gave an average corrosion rate of 604 micron/yr, but this was based on the original surface area of 150 cm<sup>2</sup>. However, with the control coupons, the surface area was being reduced, until at completion of the test only about 10 - 15% of the original coupon remained (see Fig XI). This would therefore compare favourably with expected corrosion rates in an Accelerated Low Water Corrosion environment of 1100 – 1200 micron/yr.

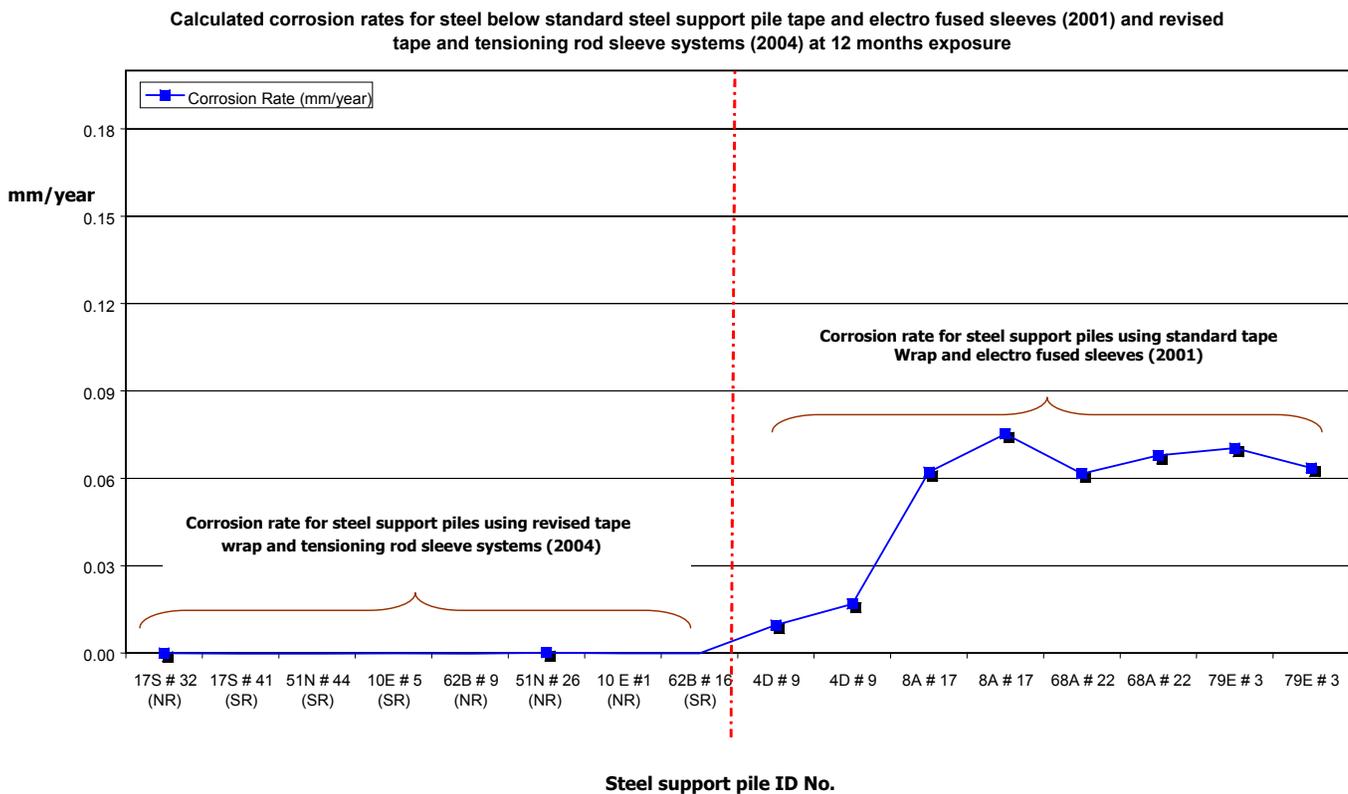
Fig XII. Graph comparing corrosion rates between the standard electro-fused sleeve system versus the new tensioning rod system.

Review of the final results show that corrosion degradation is significantly less below the newly introduced tape wrap and tensioning rod sleeve system over the old tape wrap and electro-fused sleeve system. The weight loss for the original tape wrap and electro-fused sleeve system employed for steel support pile protection gave an average corrosion rate of 3.4 microns/yr. The corrosion rate for the re-designed system specified in 2003 gave an average corrosion rate of 0.07 microns/yr, which is negligible.

Review of the graph in Fig XII clearly shows the difference in corrosion rates between the older type electro-fused system versus the newer tensioning rod sleeve system.

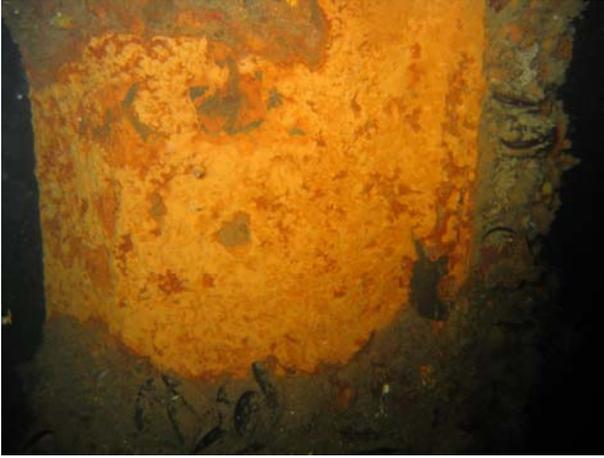
**Fig XIII.** View of steel support pile showing “orange bloom” of about 500mm x 700mm associated with Microbially Influenced Corrosion (MIC).

The most obvious signs that MIC is evident on structures experiencing ALWC is the familiar tell tale sign of an “orange bloom”. This bloom has become an accurate indicator of active MIC and more particularly the presence of (SRB). To date, although orange blooms are recognized as a tell tale sign of ALWC, no identification of the organisms which make up the “orange bloom” have been conducted. Currently, microbial and analytical testing is being conducted to identify the “orange bloom” constituents at Fremantle Ports.

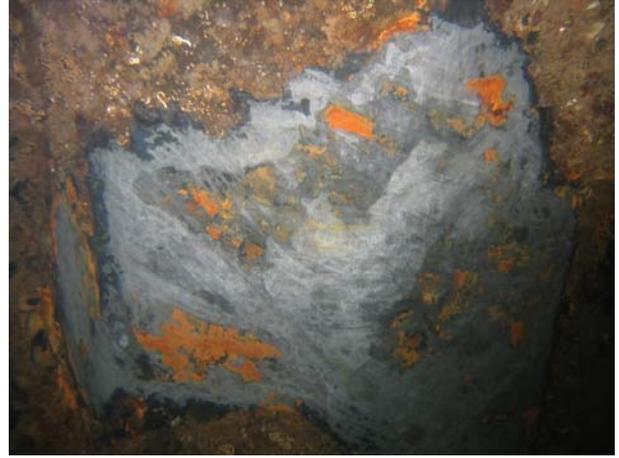
**Fig XIV.** View of steel support pile showing “orange bloom” removed, revealing shiny pitted steel below.

Corrosion by SRB has been well documented. The corrosion morphology of the underlying steel is almost always localised and the pitting tends to be smooth and hemispherical. The microbes can be waterborne, and they can exist under a protective tubercle or other protective material (protective tape systems/fouling) that allows for an anaerobic environment on the substrate surface. Because of the extremely localised attack of these bacteria, the degradation to the steel surface at these locations can be extremely severe, while the surrounding substrate may show minimal (if any) signs of deterioration.
